**Site/Project Location:** MP 1 Spread 7-8 SE Johnsons Corner Terminal **Date of Inspection:** 24 August 2016  
Pipeline ROW southeast of DAPL's Johnsons' Corner terminal in McKenzie County.

**212 PU-14-842** Filed: 9/2/2016 Pages: 4  
**Site Inspection Trip Report – August 24, 2016**

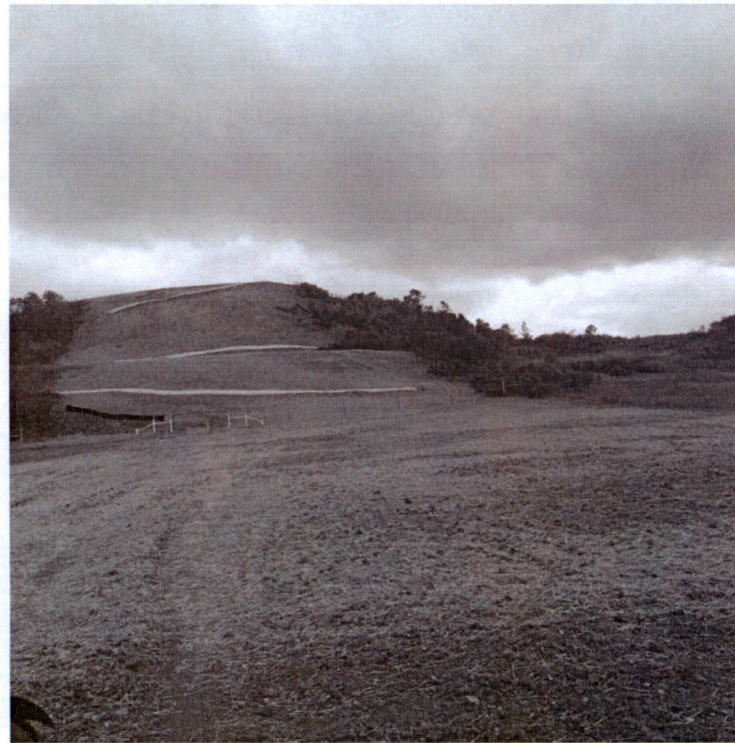
47.7878°N 102.9042°W

**Report Photo #2 "Pipeline ROW Southeast of Johnsons Corner Looking SSW":**

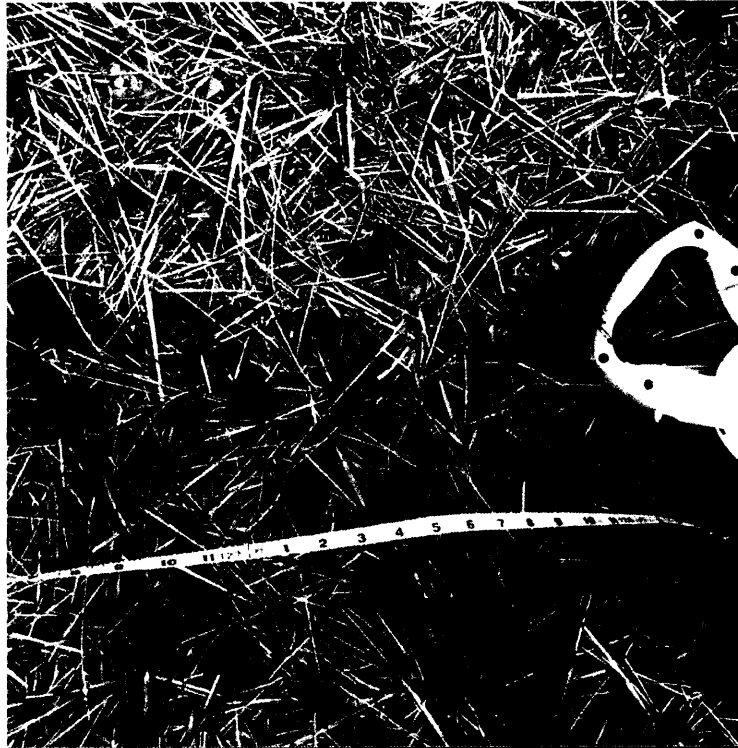
47.7863°N 102.9055°W

Tree removal extended significantly beyond 85 feet approved in revised ND Public Service Commission order. The narrowest area identified was just short of 127 feet wide. Other portions of the trees in the ROW were removed to even a wider width. No indication, however, that stripped area exceeded area of entire easement.

**Report Photo #3 "Narrowest Point of Tree Removal 126 feet 9 inches":**

Will report to PSC staff for follow-up action. Will perform post remediation inspection at this site.

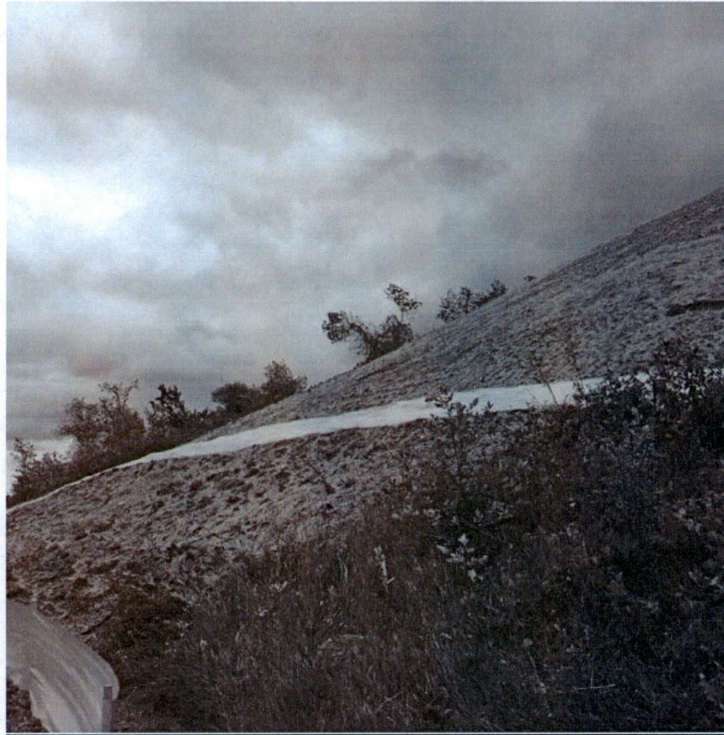
47.7861°N 102.9055°W

Blown straw cover was not crimped into topsoil.

**Report Photo #5 "High Slope on North Side of Bluff Looking ESE":**
